# Assessment of a Railway Vibration Quality Indicator

**Through an analysis of field vibration measurement data  
ProRail**

19 February 2024 - Restricted

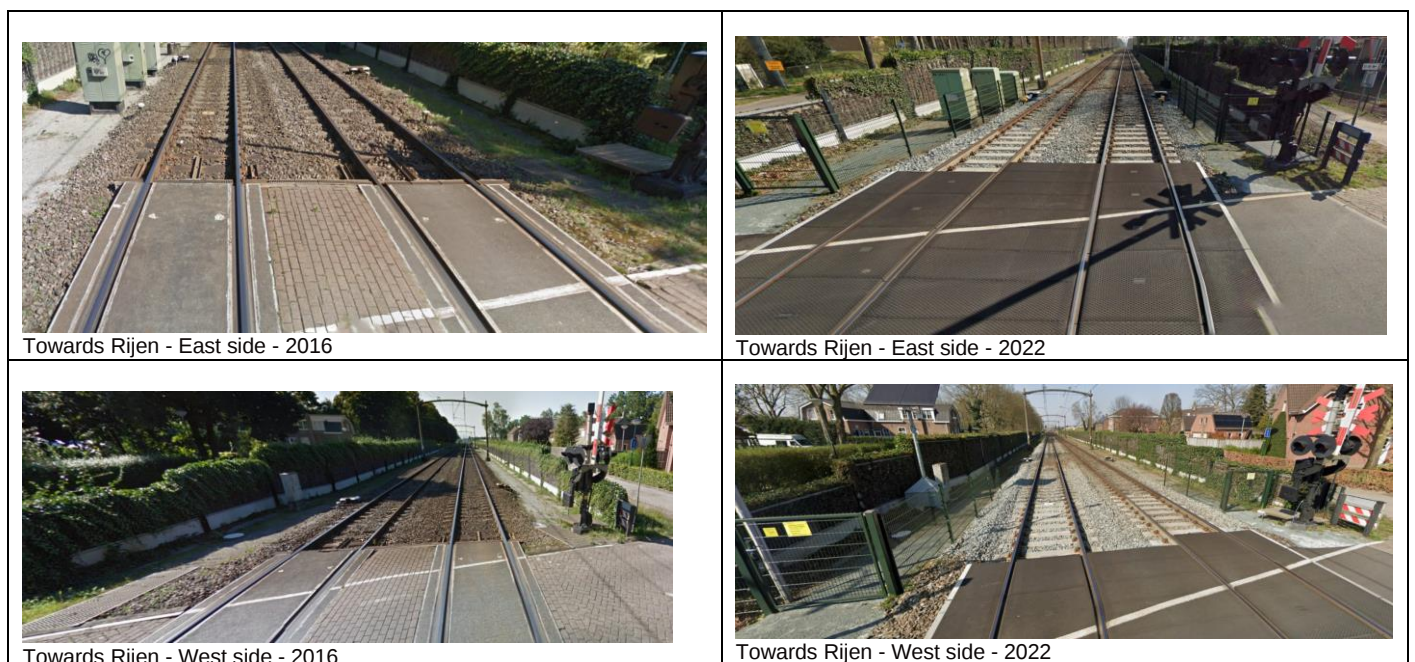
Witteveen+Bos and D2S International conducted a study [3], commissioned by ProRail, to quantify the effect of replacing concrete slabs at level crossing with rubber panels on railway vibrations. The practical test location is at a level crossing at Spoorstraat/Wethouder van Dijklaan in Dorst. The vibration measurement results are available in the D2S documents ([4] and [5]), which are included as appendices in [3]. During the modification work, the level crossing was replaced and the insulated joint welds on both sides were also renewed. The track modifications before and after maintenance are shown in Figure 2 for comparison.

Figure 2 Track modifications before and after level crossing replacement (source: Google Earth).

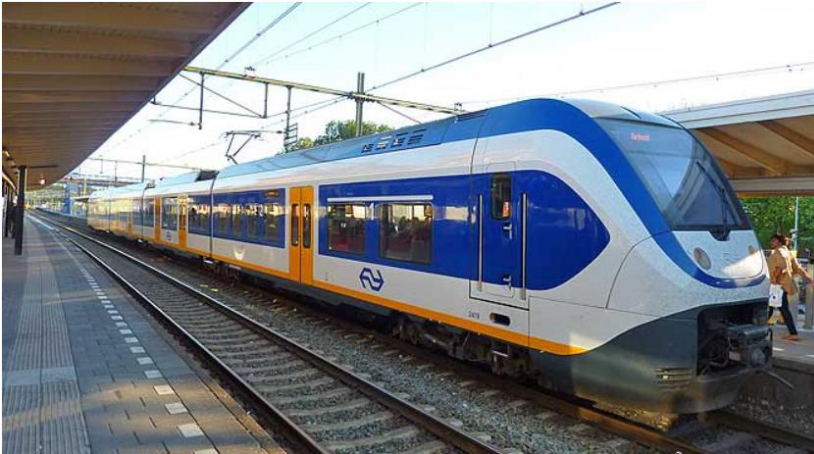
The Sprinter, also referred to as SLT (NS commuter train), is mainly used for shorter distance journeys within the Netherlands. They are single-decker trains, powered by electricity and do not have a separate locomotive. With a maximum speed of around 140 km/h, they are typically found in urban areas and make frequent stops at various stations. Figure 6 shows an example of a Sprinter.

The length of Sprinter trains is approximately 75 to 80 m. The length can vary based on the train composition.

Figure 6 Example of NS Sprinter Light train (SLT) – Source: Amsterdamtips.com

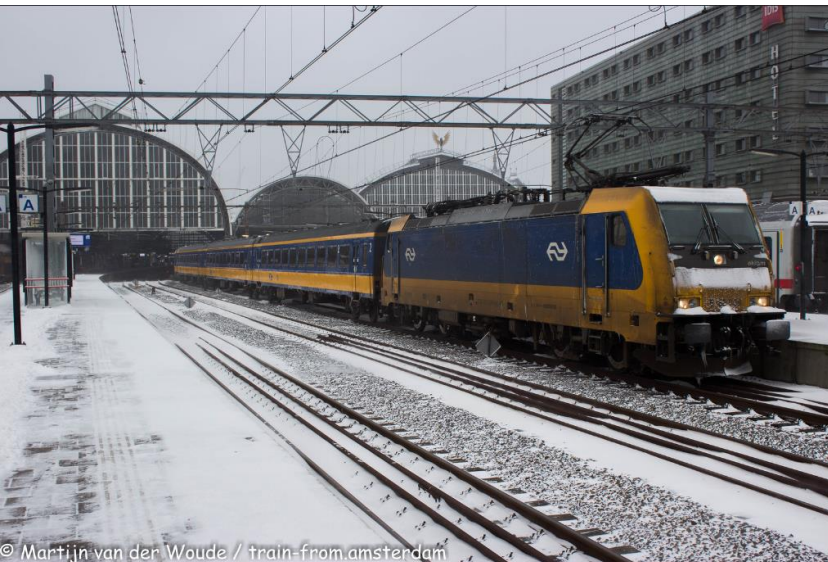
The TRAXX, also referred to as “intercity direct train” or TRAXX F140 locomotive (Alstom former Bombardier), is used for both intercity and international services. The train composition consists of 6 ICR passenger cars between 2 TRAXX F140 locomotives. However, these trains are designed to be versatile and can be used in various configurations, such as incorporating multiple locomotives or having a single locomotive, in order to meet the specific needs of the railway operator. These trains are electrically powered and can also run on diesel in certain cases. They have a maximum speed of around 160 km/h and are frequently used for cross-border services, connecting the Netherlands with its neighboring countries. Figure 7 shows an example of TRAXX.

The length of TRAXX trains is approximately 100 to 150 m. The length can vary based on the train composition.

Figure 7 Example of NS TRAXX train

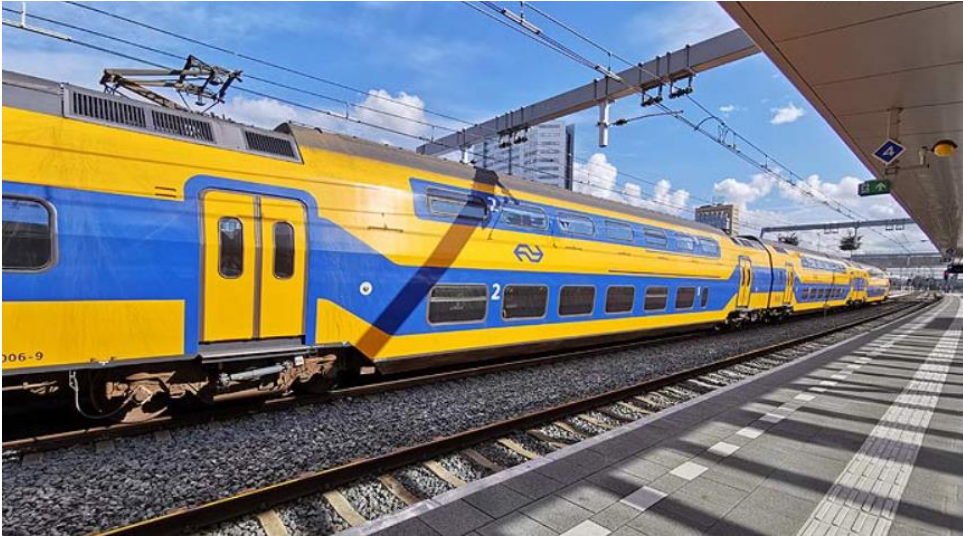
The VIRM, also referred to as NS double stock passenger train, is used for intercity services throughout the Netherlands. These double-decker trains are electrically powered and do not require a separate locomotive. VIRM trains operate with a maximum speed of around 160 km/h. An example of VIRM train is shown in Figure 8.

The length of VIRM trains is approximately 100 to 120 m. The length can vary based on the train composition.

Figure 8 Example of NS double-decker Intercity train (VIRM) - Source: Amsterdamtips.com

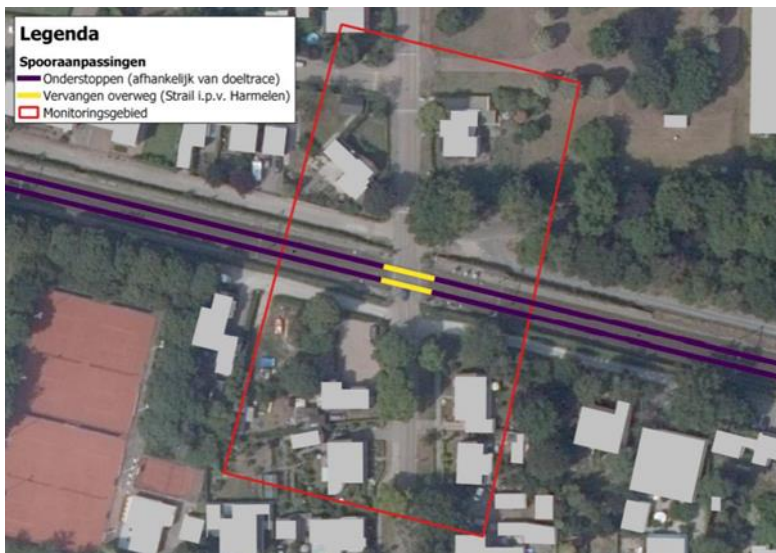
The data was collected and processed for the specified location by Level Acoustics and Vibration as shown in Figure 9:

Figure 9 Geocode 123, between km. 6.295 en km. 6.370, concerning the level crossing replacement.

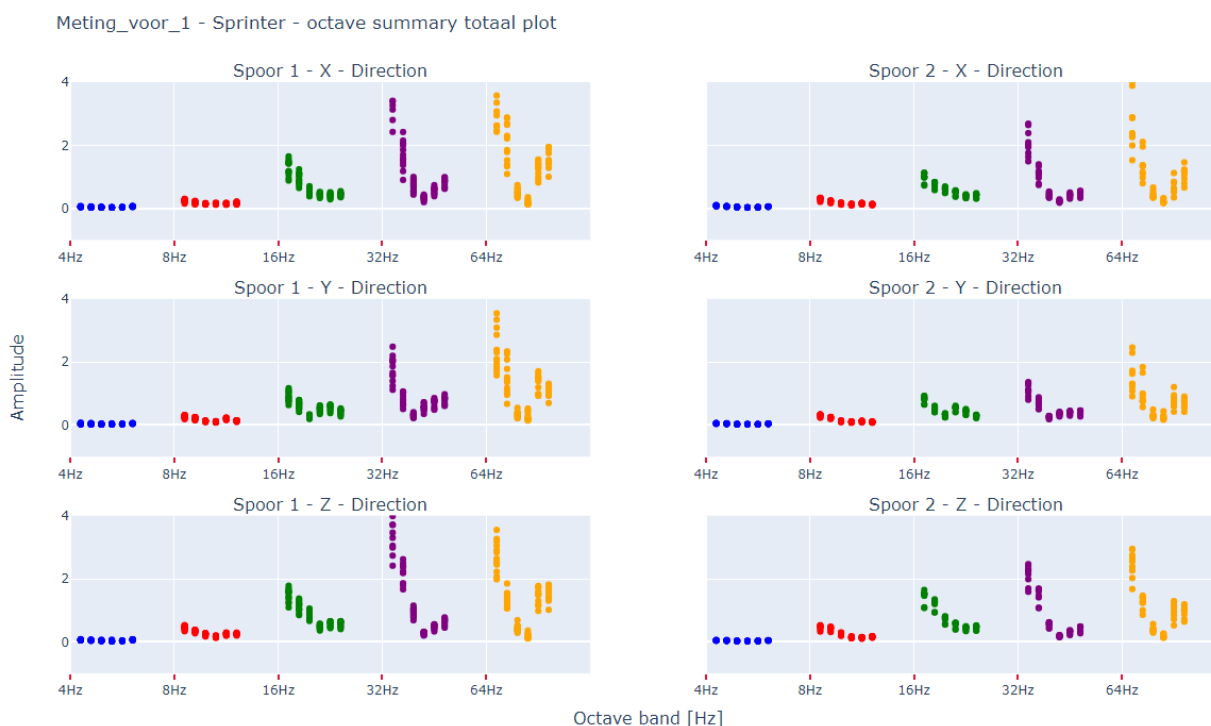
Figure 26 Vibration measurement data set 1 (Amplitude vs. octave bands) before track modification - Sprinter trains - Tracks 1 and 2, shown in the left and right figures, respectively.

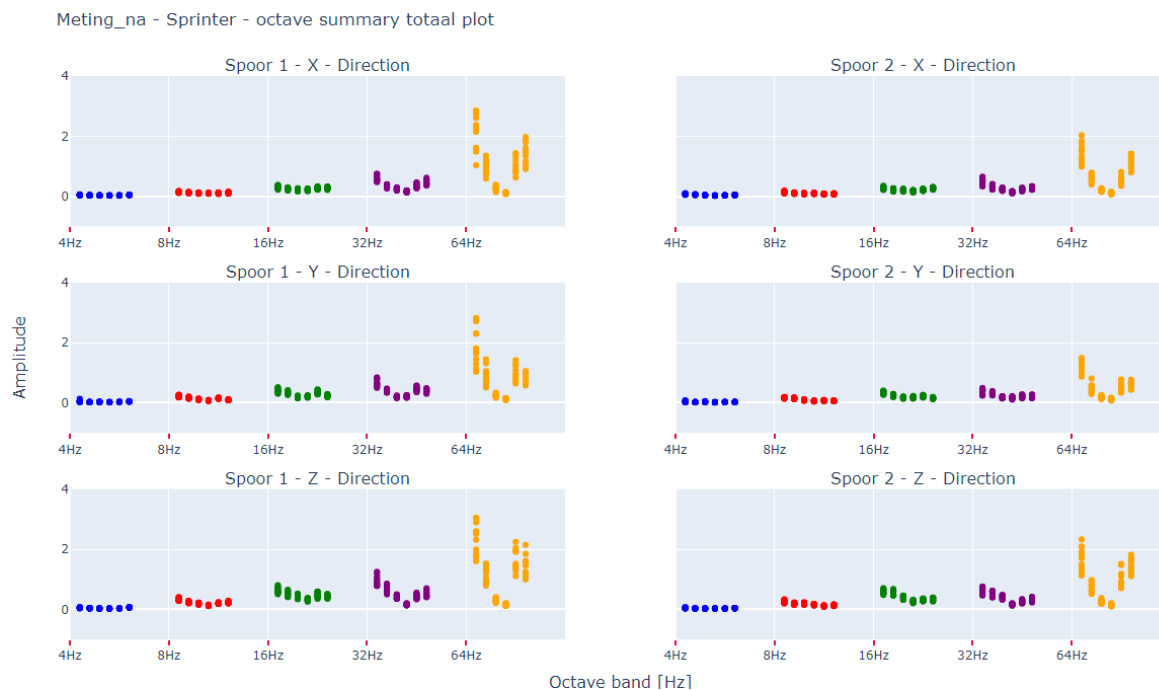
Figure 32 Vibration measurement data set (Amplitude vs. octave bands) directly after track modification - Sprinter trains - Tracks 1 and 2, shown in the left and right figures, respectively.

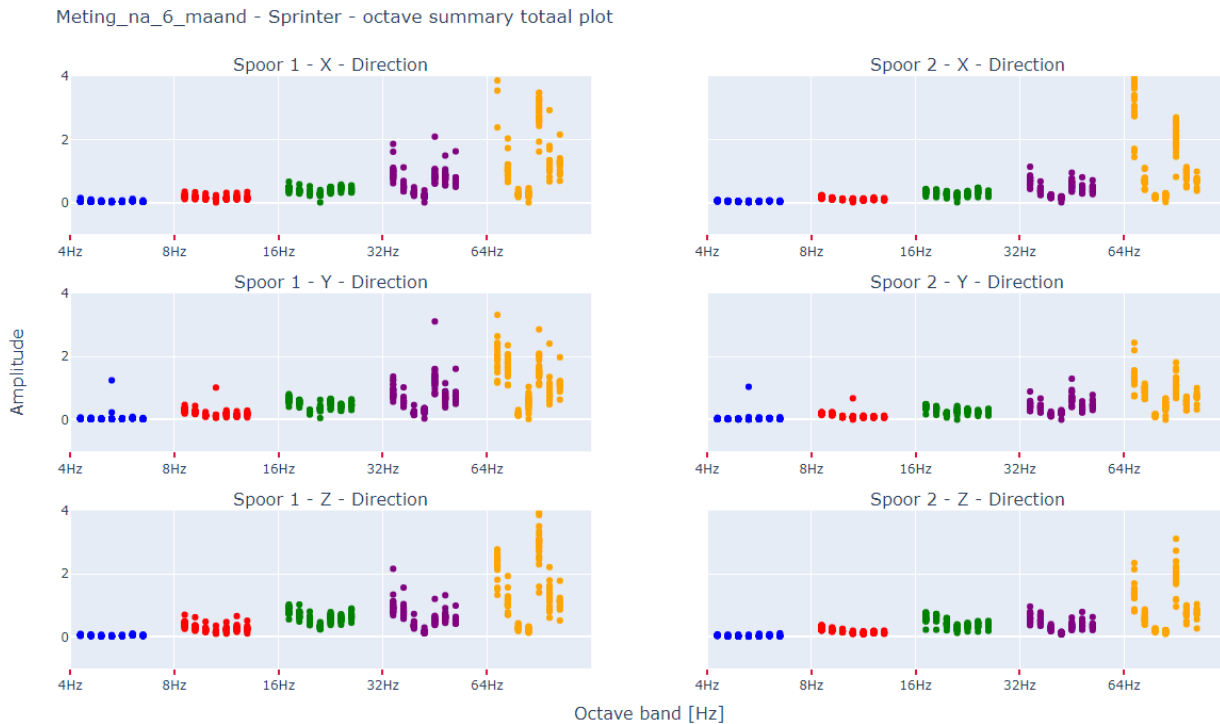
Figure 35 Vibration measurement data set (Amplitude vs. octave bands) 6 months after track modification - Sprinter trains - Tracks 1 and 2, shown in the left and right figures, respectively.

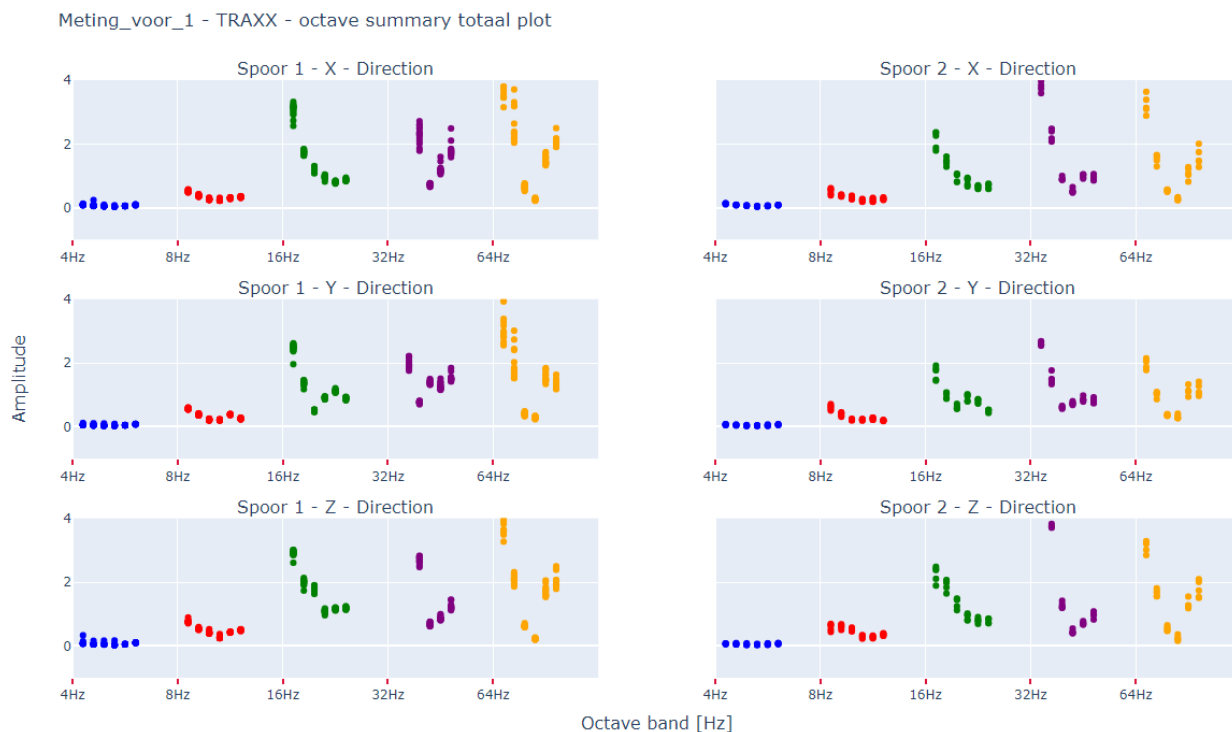
Figure 41 Vibration measurement data set 1 (Amplitude vs. octave bands) before track modification - TRAXX trains - Tracks 1 and 2, shown in the left and right figures, respectively.

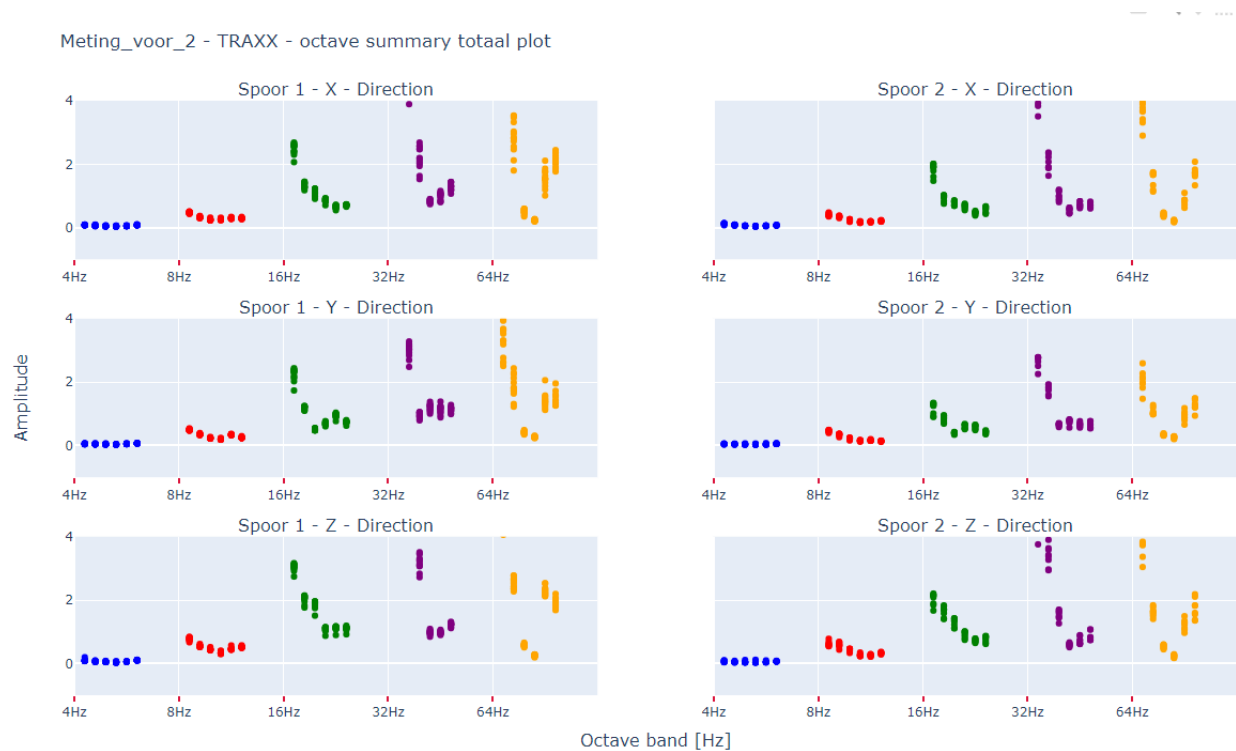
Figure 44 Vibration measurement data set 2 (Amplitude vs. octave bands) before track modification - TRAXX trains - Tracks 1 and 2, shown in the left and right figures, respectively.

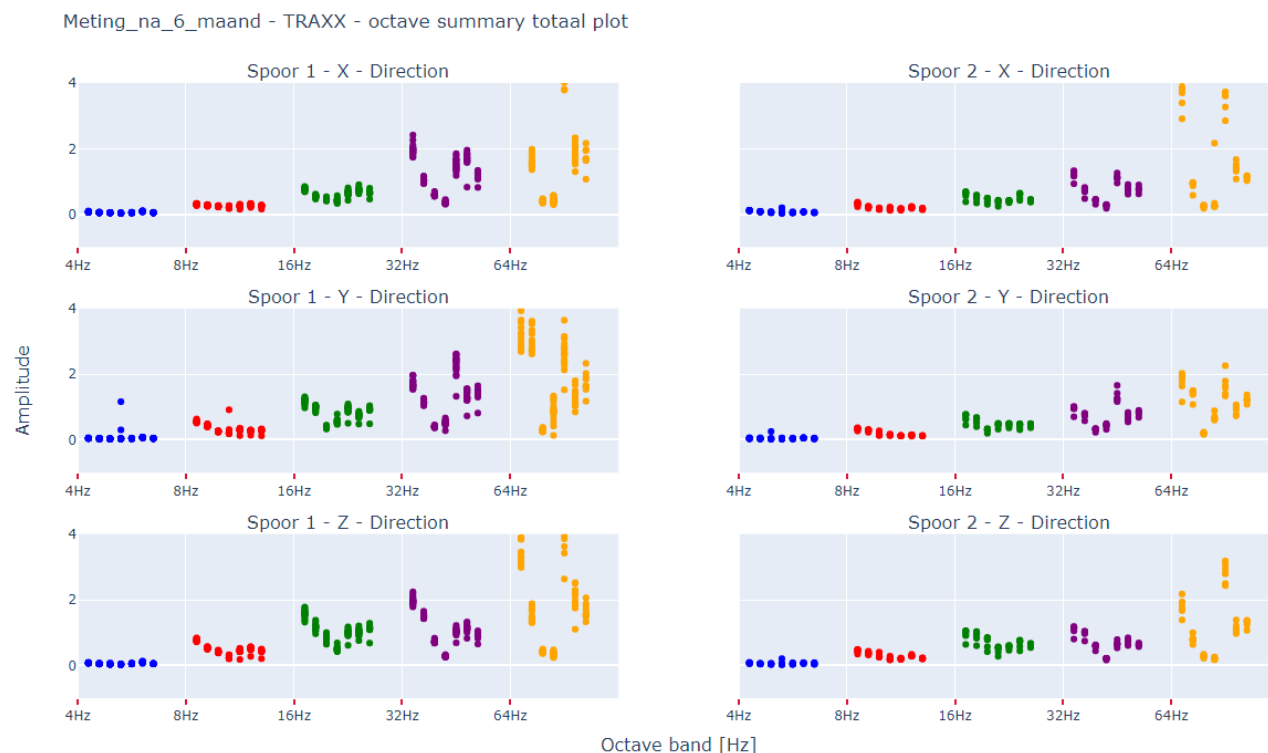
Figure 50 Vibration measurement data set (Amplitude vs. octave bands) 6 months after track modification - TRAXX trains - Tracks 1 and 2, shown in the left and right figures, respectively.

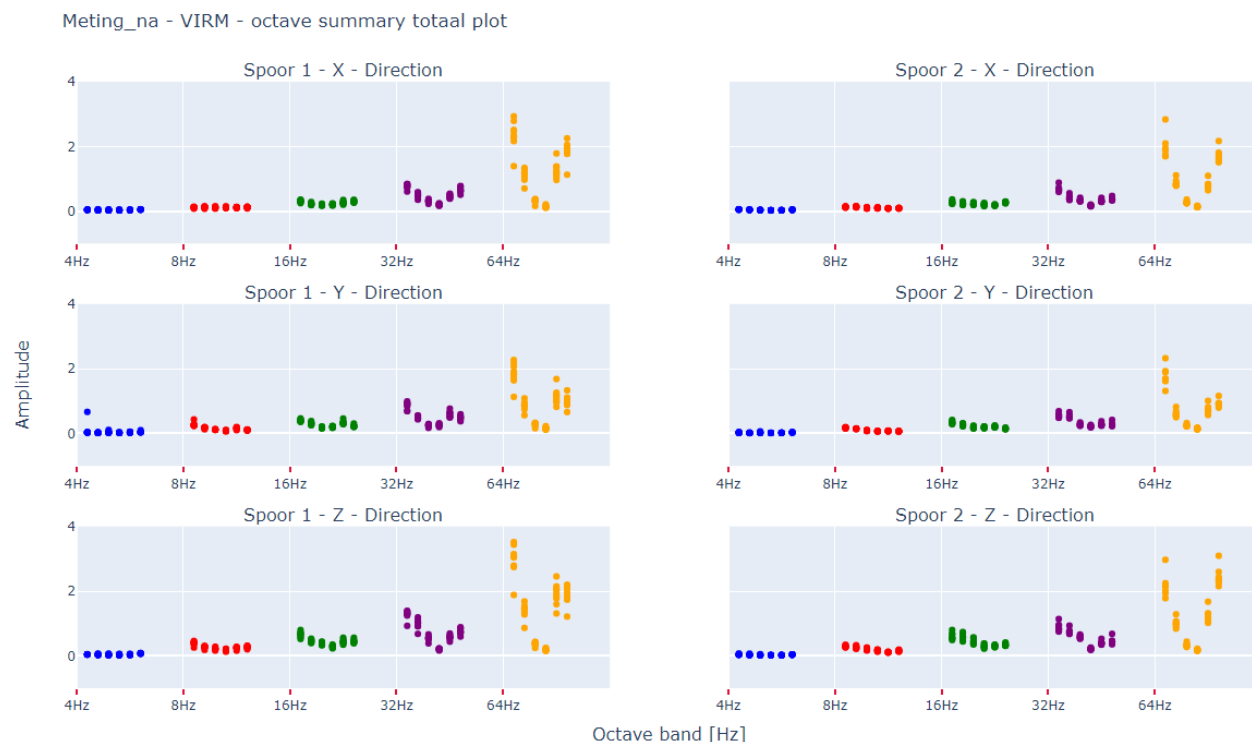
Figure 62 Vibration measurement data set (Amplitude vs. octave bands) directly after track modification - VIRM trains - Tracks 1 and 2, shown in the left and right figures, respectively.

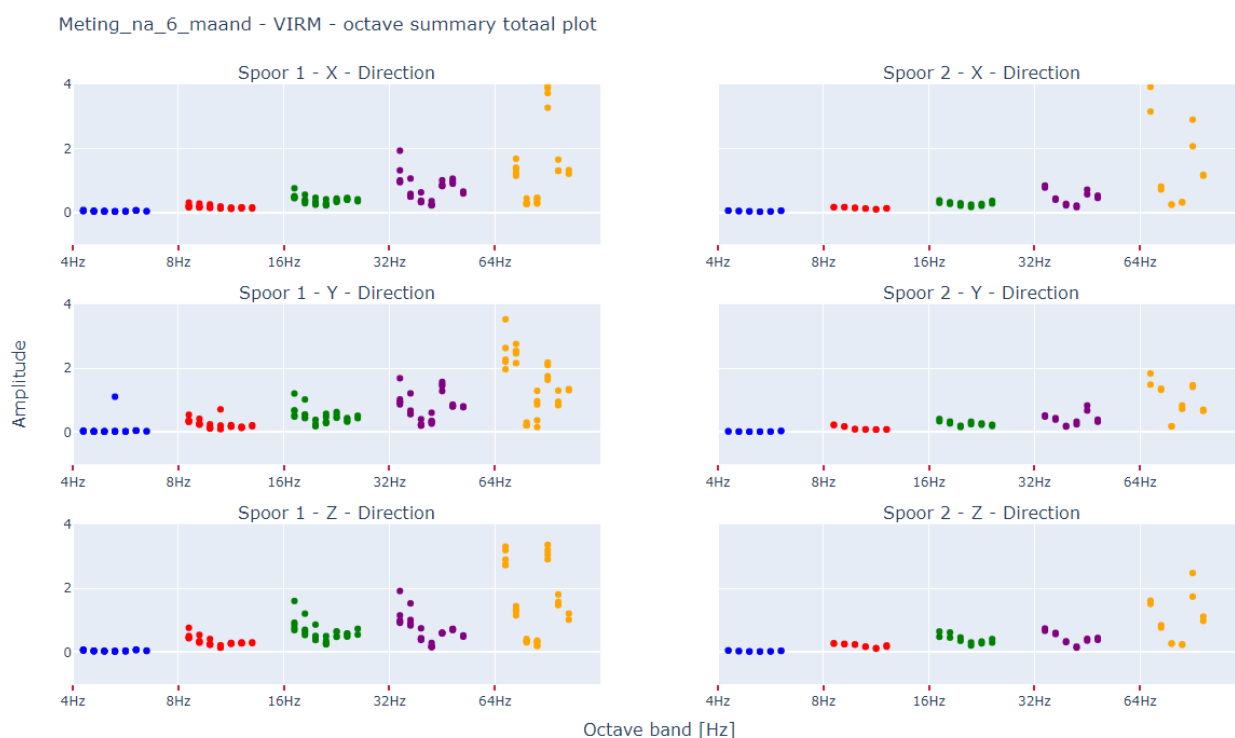
Figure 65 Vibration measurement data set (Amplitude vs. octave bands) 6 months after track modification - VIRM trains - Tracks 1 and 2, shown in the left and right figures, respectively.
